## Water Voles & development

### Case study: A1073 Eye to Spalding

This project was part of extensive ecological assessment and management work involved in the A1073 Road Improvement Scheme.

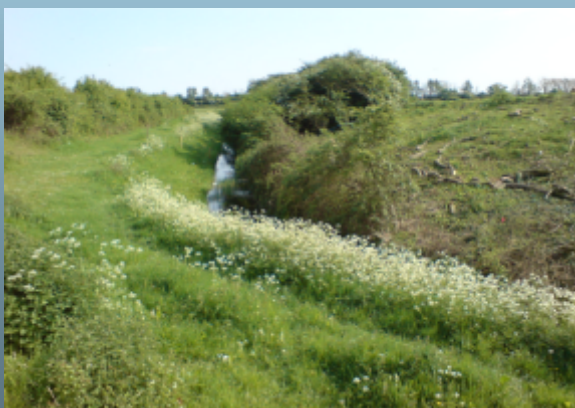
The presence of Water Vole was confirmed along a twelve-metre stretch of bank of Carr Dyke, approximately 50 metres from the CPO boundary.

*Carr Dyke*
