Case study: Thursley Junction, A3 Surrey – an award-winning design.

- This project involved creation of a new slip road on the A3, partially within Thursley NNR, SPA and SAC.
- The project's land take included suitable reptile habitat, resulting in the possible displacement of common lizards, slow worms and adders.

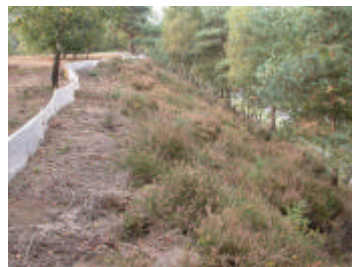
Snake hibernaculum under construction at Thursley (Picture courtesy Goddards)

- Habitat was improved within retained areas through the construction of hibernacula, combined with vegetation management to improve habitat quality.
- The retention of valuable heathland habitat in the mitigation strategy resulted in MKA Ecology being awarded with the BALI Special Award for Nature Conservation in 2004.

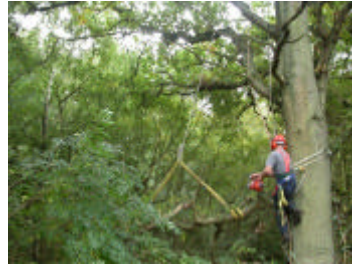
Oak branch being carefully lowered before inspection by bat worker
